STM GREASE HUB SEAL & A.B.S SENSOR/BRACKET INTERFERENCE

This Technical Publication outlines potential STM Grease Hub Seal (Hand Fit) interference with some Trailer Axles fitted with Anti-Lock Braking Systems (A.B.S).

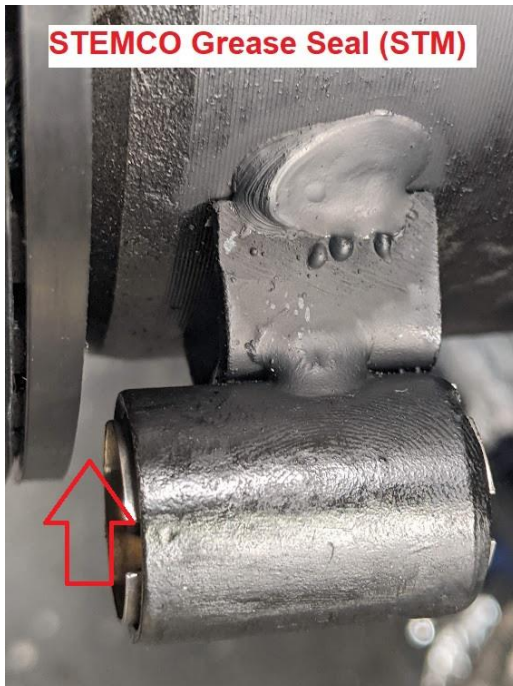
- The STM Grease Hub Seal (Hand Fit) can make contact against the A.B.S components fitted to the trailer axle. Damage to the STM Grease Hub Seal can be a direct result from the seal making contact to the external axle components (The STM Grease Hub Seal needs to rotate *without* any interference).
- Due to the design of the STM Grease Hub Seal & the height (28.80mm+/- 0.40mm) of the seal, it can protrude at a higher point.

Pic #1
Low Clearance

- If the STM Grease Hub Seal does not have adequate clearance (when the Hub Seal is fully seated into the hub bore) and makes contact with any A.B.S components when the hub is installed onto the axle, then it's recommended to replace the hub seal with an alternative STEMCO product.
- Alternative STEMCO tool fit hub installed (Voyager & Discover XR) & axle installed (Guardian HP) seals have a lower height profile (Pic #4).

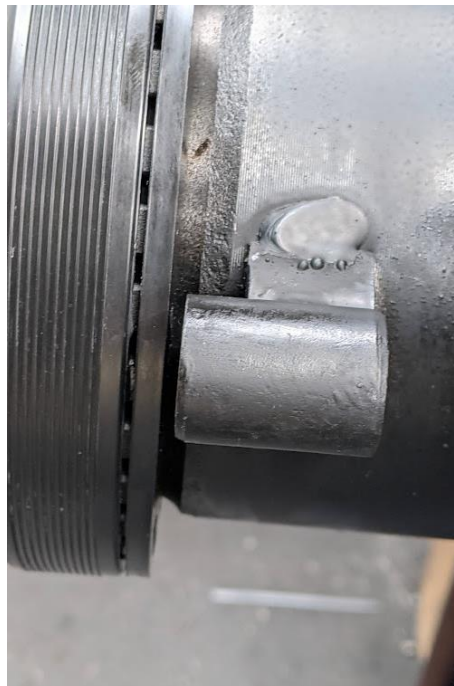
Pic #2
Low Clearance

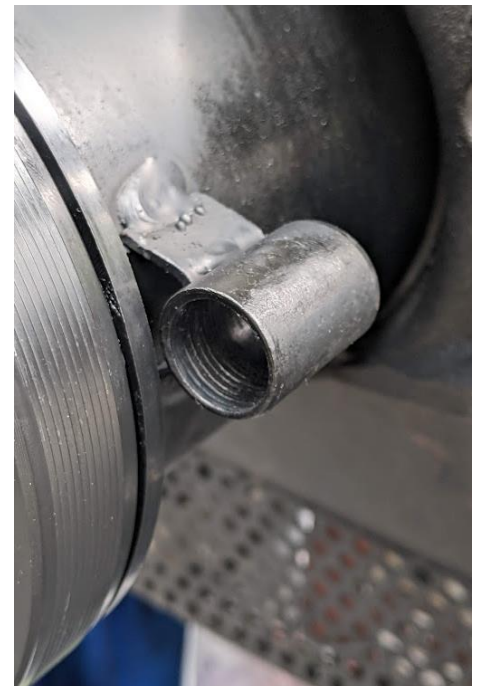
Pic #3
Low Clearance

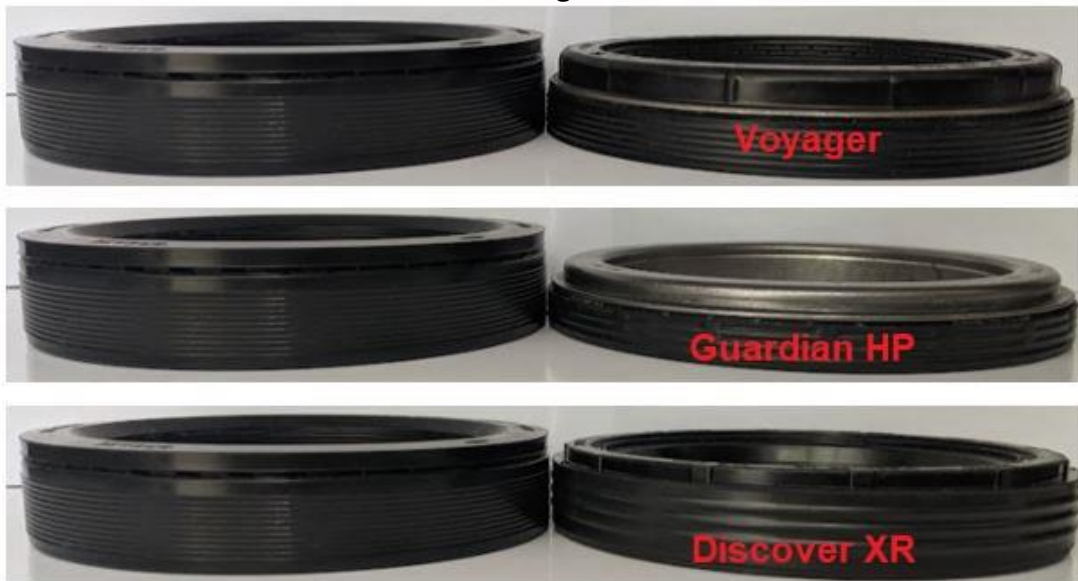
Pic #4
STEMCO Height Profile

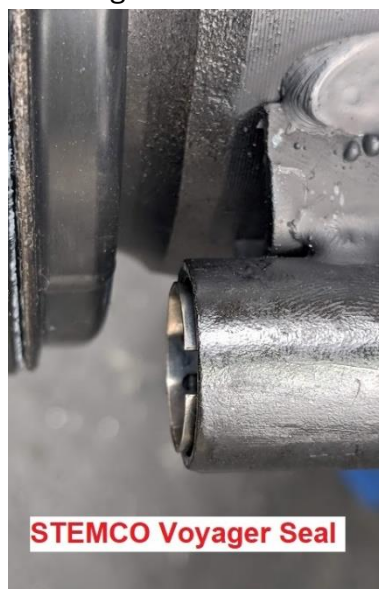
- As per below (Pic #5) other STEMCO seals can be used as a replacement with reasonable clearance & will not make contact A.B.S components.

Pic #5
Higher Clearance
