Case Study: Garlock 3760 Seals Large Pipe with Damaged Flange

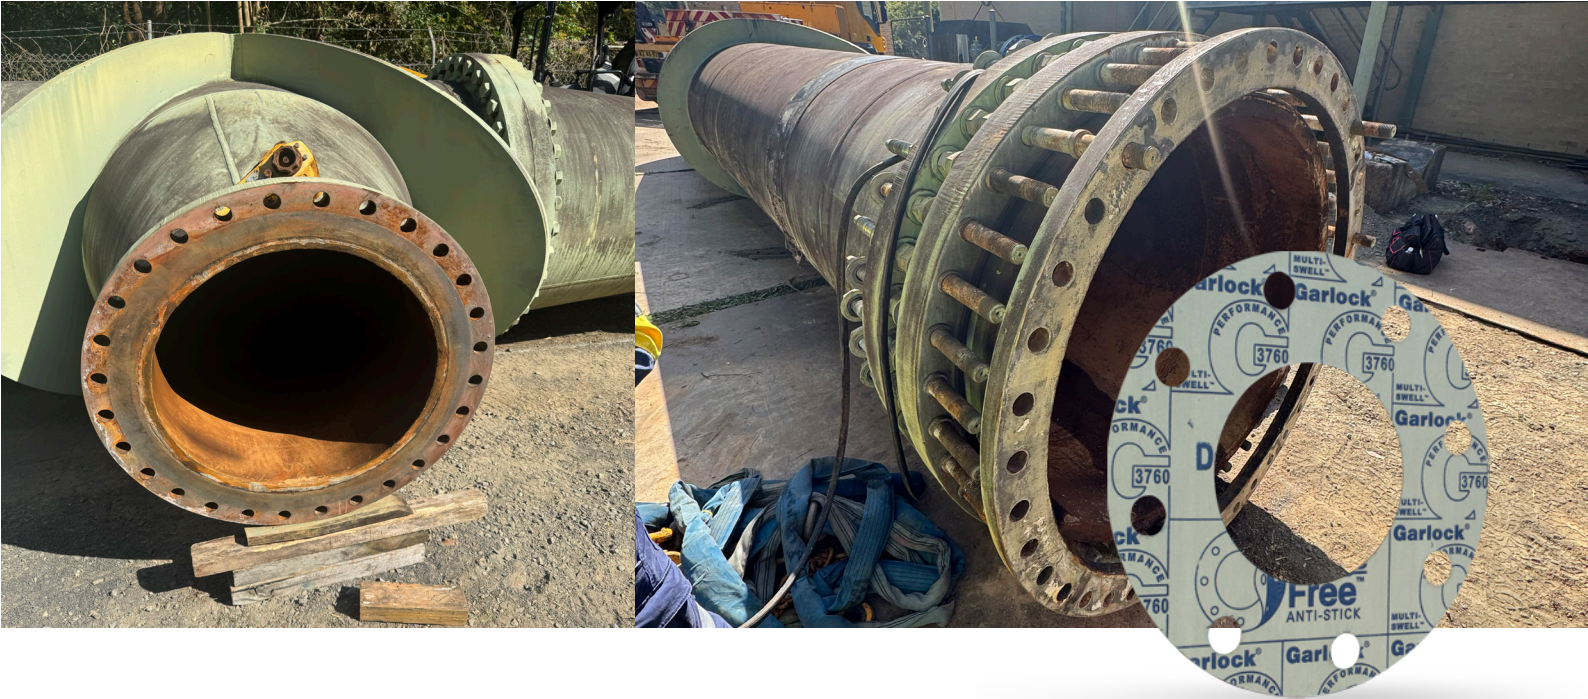
A water pumping facility approached Garlock seeking a reliable gasket solution for large-diameter flanges in a potable water system. The flanges were heavily rusted and damaged, creating significant sealing challenges. The customer had a history of successful projects with Garlock and trusted our expertise to deliver a solution that would meet strict potable water standards while ensuring long-term performance.

The project required sealing large-diameter flanges with uneven surfaces, which made achieving a secure seal extremely difficult. Rust and surface damage compromised standard sealing methods, and access to the pipework was limited, requiring crane assistance for inspection and handling. The dismantling process was further complicated by custom-made joints, adding time pressure to an already challenging situation. Compliance with potable water gasketing requirements was essential, making material selection critical to success.

Garlock recommended MULTI-SWELL® Style 3760 gaskets for their unique ability to compensate for uneven flange surfaces and maintain a reliable seal under low assembly stress. The gasket's controlled swelling capability was a key advantage: when exposed to water, the material expands slightly, filling in surface imperfections and irregularities. This swelling action created a tighter seal across the damaged flange, eliminating leak paths that traditional gaskets could not address. Combined with its high compressibility, MULTI-SWELL® ensured long-term sealing performance even under challenging conditions. The solution met potable water compliance requirements and allowed the project to proceed without delays, minimising downtime and ensuring system integrity for years to come.
